No. 1246

WIND-TUNNEL INVESTIGATION OF ICING OF AN ENGINE
COOLING-FAN INSTALLATION

By James P. Lewis

TECHNICAL NOTE NO. 1246

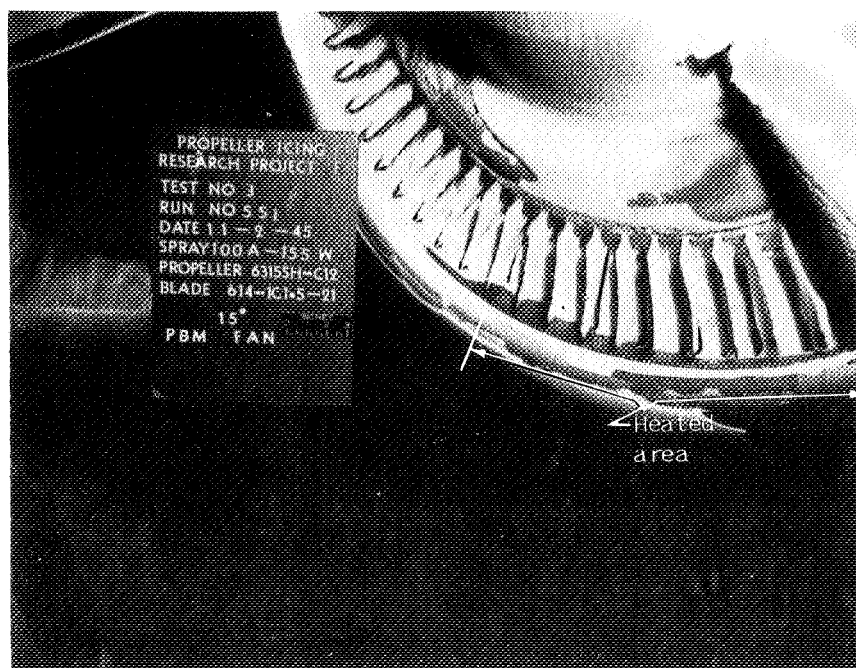
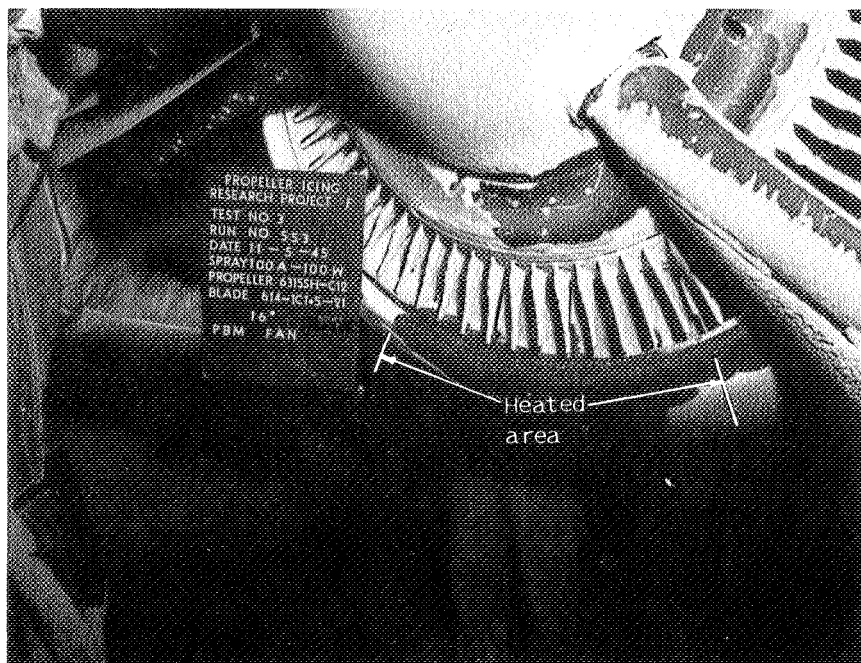
(a) Close-up showing de-icing with single steam line. Air temperature, 13°F ; liquid-water content, 0.4 gram per cubic meter; fan speed, 874 rpm.

(b) Close-up showing de-icing with double steam line. Air temperature, 16°F ; liquid-water content, 0.5 gram per cubic meter; fan speed, 917 rpm.

Figure 15. - Views showing effect of steam-heat de-icing of cowl and inlet duct in cooling-fan installation after 5 minutes of icing.

Steam-heat de-icing. - The results of a brief qualitative investigation of the use of steam for de-icing the cowling lip and inlet duct are shown in figure 15. Figure 15(a) shows the results of de-icing with a single steam line placed outside the inlet duct at the tip of the fan blades. The heated area started to throw off ice 50 seconds after the steam was turned on and all the ice was removed within 2 minutes with the heated area remaining clear thereafter. In a delayed de-icing run with the same configuration, steam was turned on after 5 minutes of icing and the ice in the heated area was thrown off within 30 seconds. With the double steam line installed (fig. 15(b)), a slightly greater area including the lip of the engine cowling was de-iced in the same time. From these results, it appears that the de-icing of these areas by means of hot gases is entirely feasible.

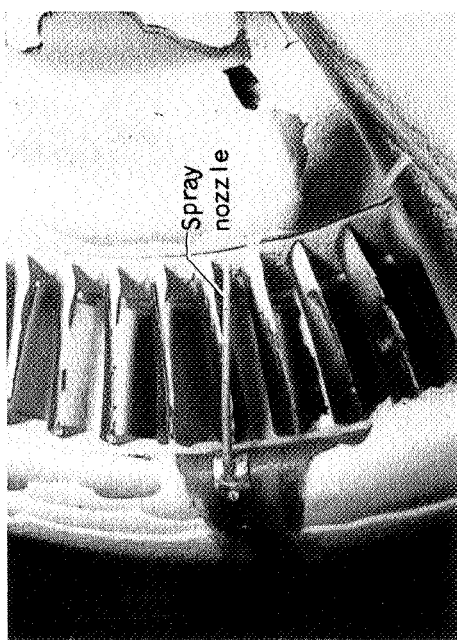
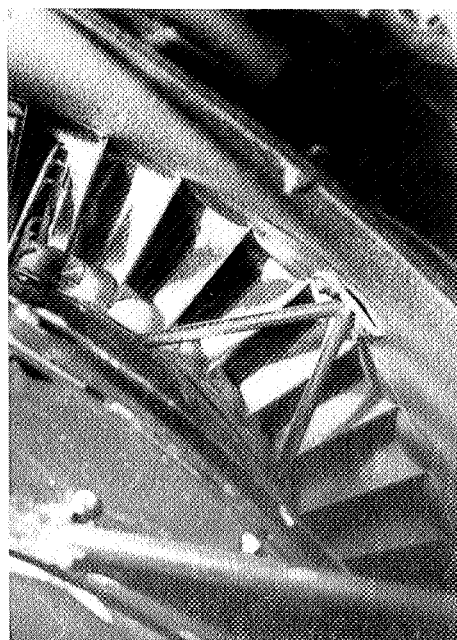
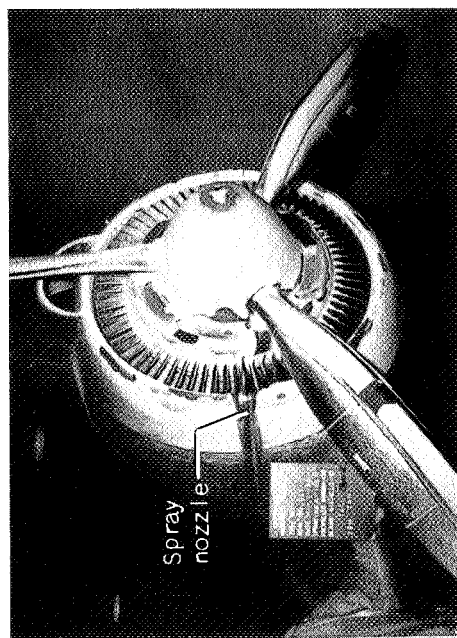
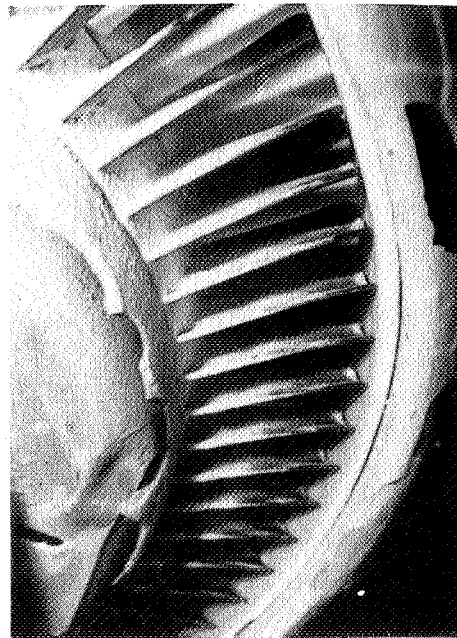
(b) Close-up of spray nozzle bar.

(d) View looking forward through stator vanes.

(a) General view of installation.

(c) Close-up of thrust face of fan blades.

Figure 16. - Views showing effect of alcohol de-icing of cooling-fan installation at air temperature of 130° F, liquid-water content of 0.4 gram per cubic meter, fan speed of 895 rpm, and alcohol flow of 0.5 pound per minute.

Alcohol de-icing. - The results of the use of alcohol sprays are shown in figures 16 to 20. At an alcohol flow of 0.5 pound per minute and with the initial spray configurations, fairly good de-icing of the fan blades was obtained at an air temperature of 130° F and liquid-water content of 0.4 gram per cubic meter (fig. 16). A fairly heavy accumulation of slush was retained, however, on several stator vanes that were concave upward. At a higher air temperature and water content and with the same alcohol flow (fig. 17), the fan blades were only partly de-iced and all the stator vanes were partly blocked by similar deposits of slush. When the alcohol flow was increased to 1.2 pounds per minute at

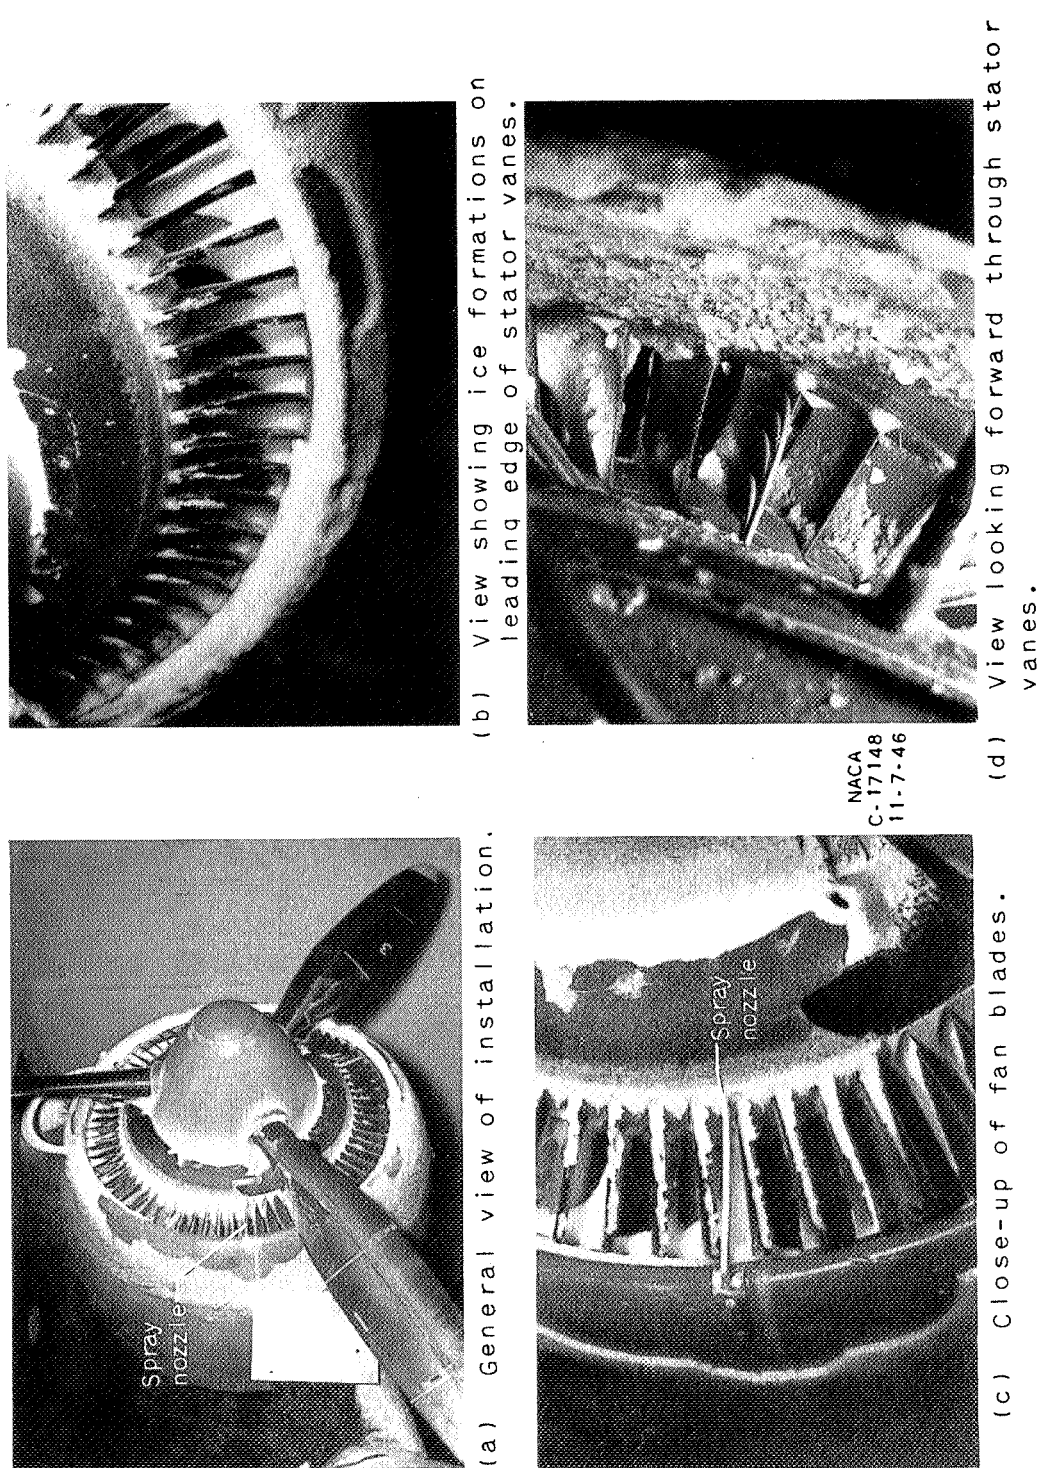
Figure 17. - Views showing effect of alcohol deicing of cooling-fan installation at air temperature of 25° F, liquid water content of 1.0 gram per cubic meter, fan speed of 875 rpm, and alcohol flow of 0.5 pound per minute.

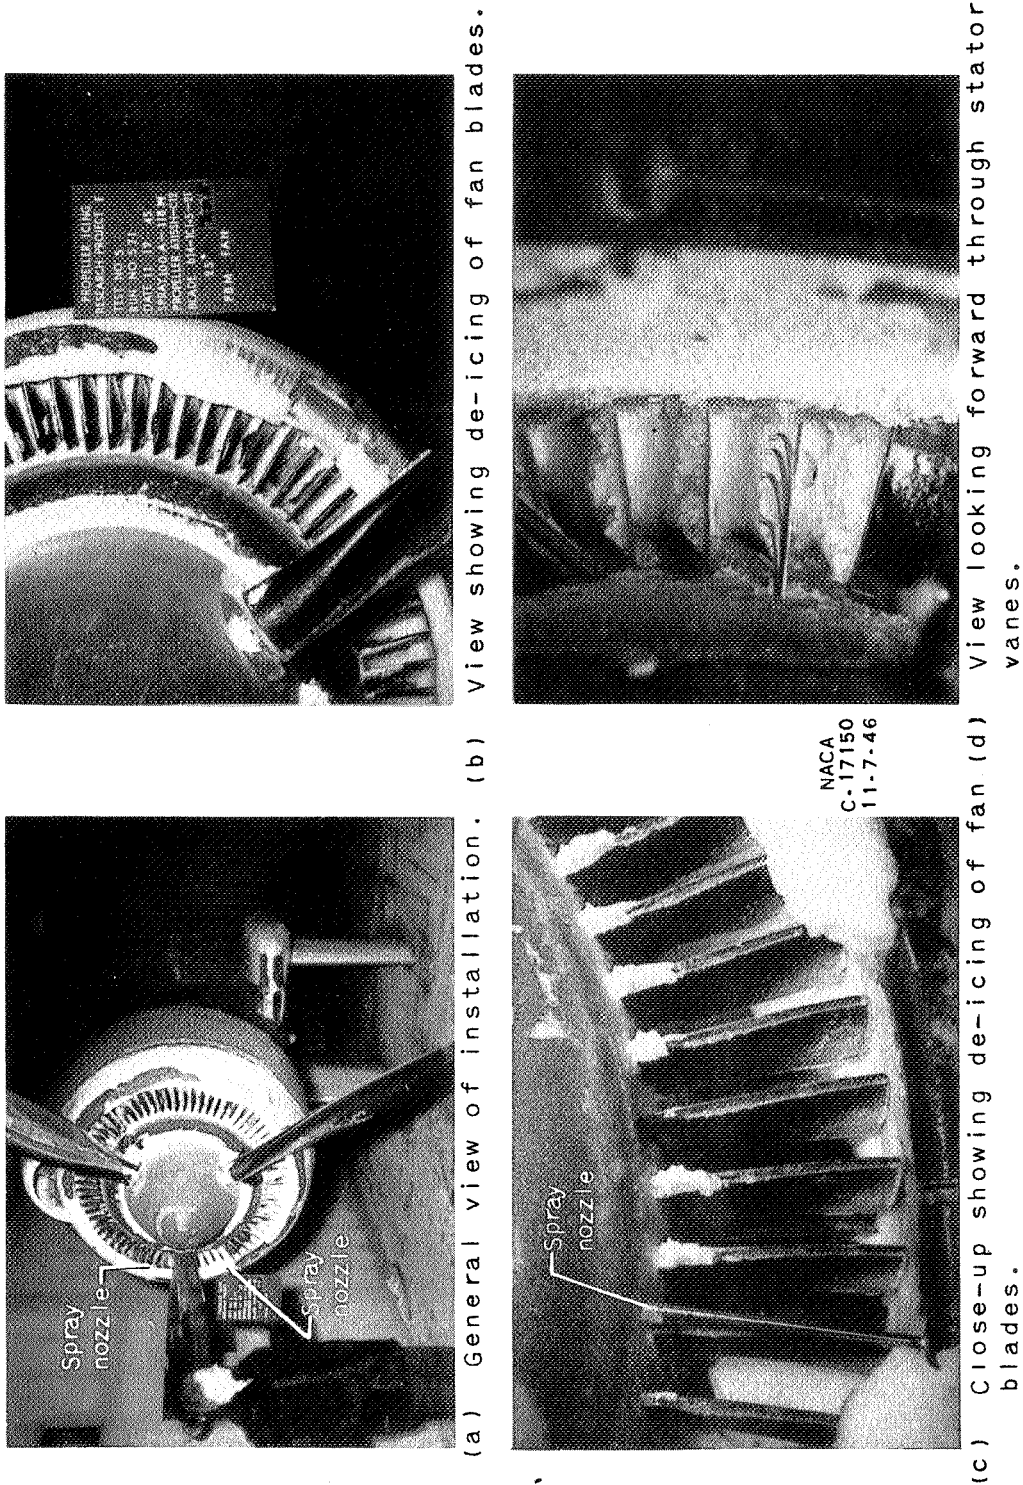
Figure 18. - Views showing effect of alcohol de-icing of cooling-fan installation at air temperature of 24° F, liquid-water content of 1.0 gram per cubic meter, fan speed of 950 rpm, and alcohol flow of 1.2 pounds per minute.

approximately the same icing and speed conditions and with the second spray configuration, no improvement in de-icing was apparent (fig. 18). Although the convex face of the fan blades was almost completely clear of ice, heavy deposits of slush were as much as three-fourths inch thick at the concave-face trailing edge. The stator vanes again had large formations of wet ice and were approximately 50-percent blocked. At a medium icing condition (air temperature, 14°F and liquid-water content, 0.5 gram/cu m) and an alcohol flow of 1.5 pounds per minute, the fan blades were almost fully de-iced. (See fig. 19.) Medium formations of wet ice were found on the stator vanes immediately behind the spray tubes and only a thin coating of ice was found on the rest of the stator blades. When the alcohol flow was increased to 2.3 pounds per minute, the fan blades were again almost completely de-iced (fig. 20). Large deposits accumulated, however, on all the stator vanes. As shown by the photographs of all the alcohol de-icing (figs. 16 to 20), the alcohol-diluted ice thrown off the fan blades impinged on the stator vanes where it remained and refroze. For all conditions, configurations, and flows investigated, the use of alcohol as a de-icing agent proved ineffective because of the marginal de-icing of the fan blades and the large ice deposits obtained on the stator vanes. It is estimated that no practical amount of alcohol would satisfactorily preserve fan performance under all icing conditions.

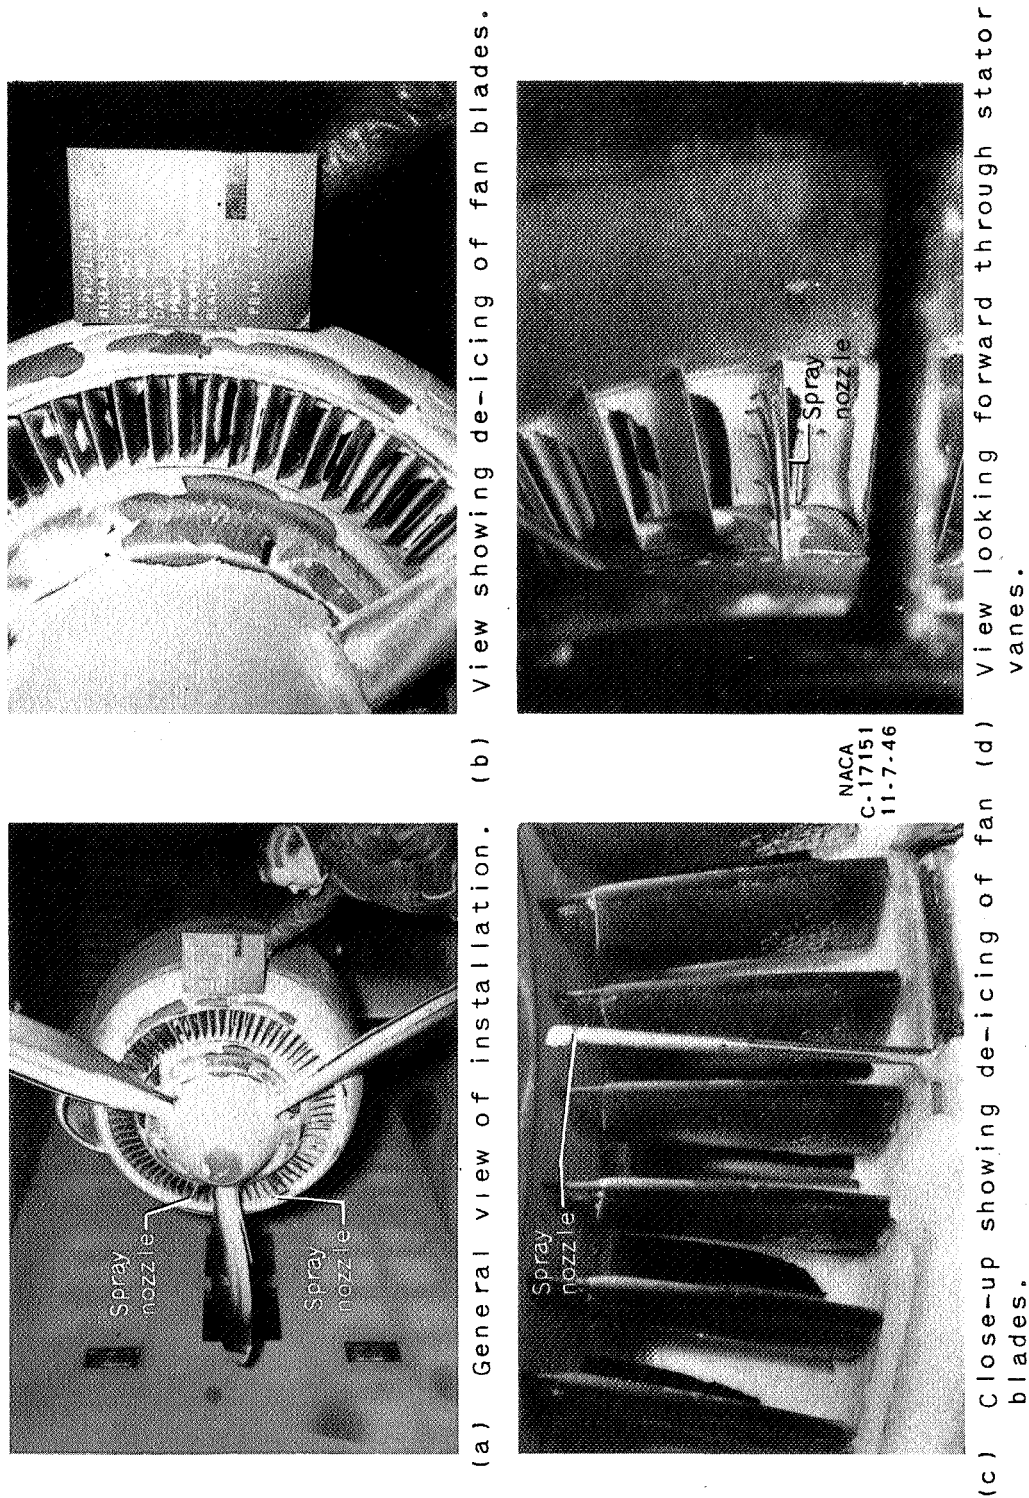
Figure 19. - Views showing effect of alcohol de-icing of cooling-fan installation at air temperature of 14° F, liquid-water content of 0.5 gram per cubic meter, fan speed of 952 rpm, and alcohol flow of 1.5 pounds per minute.

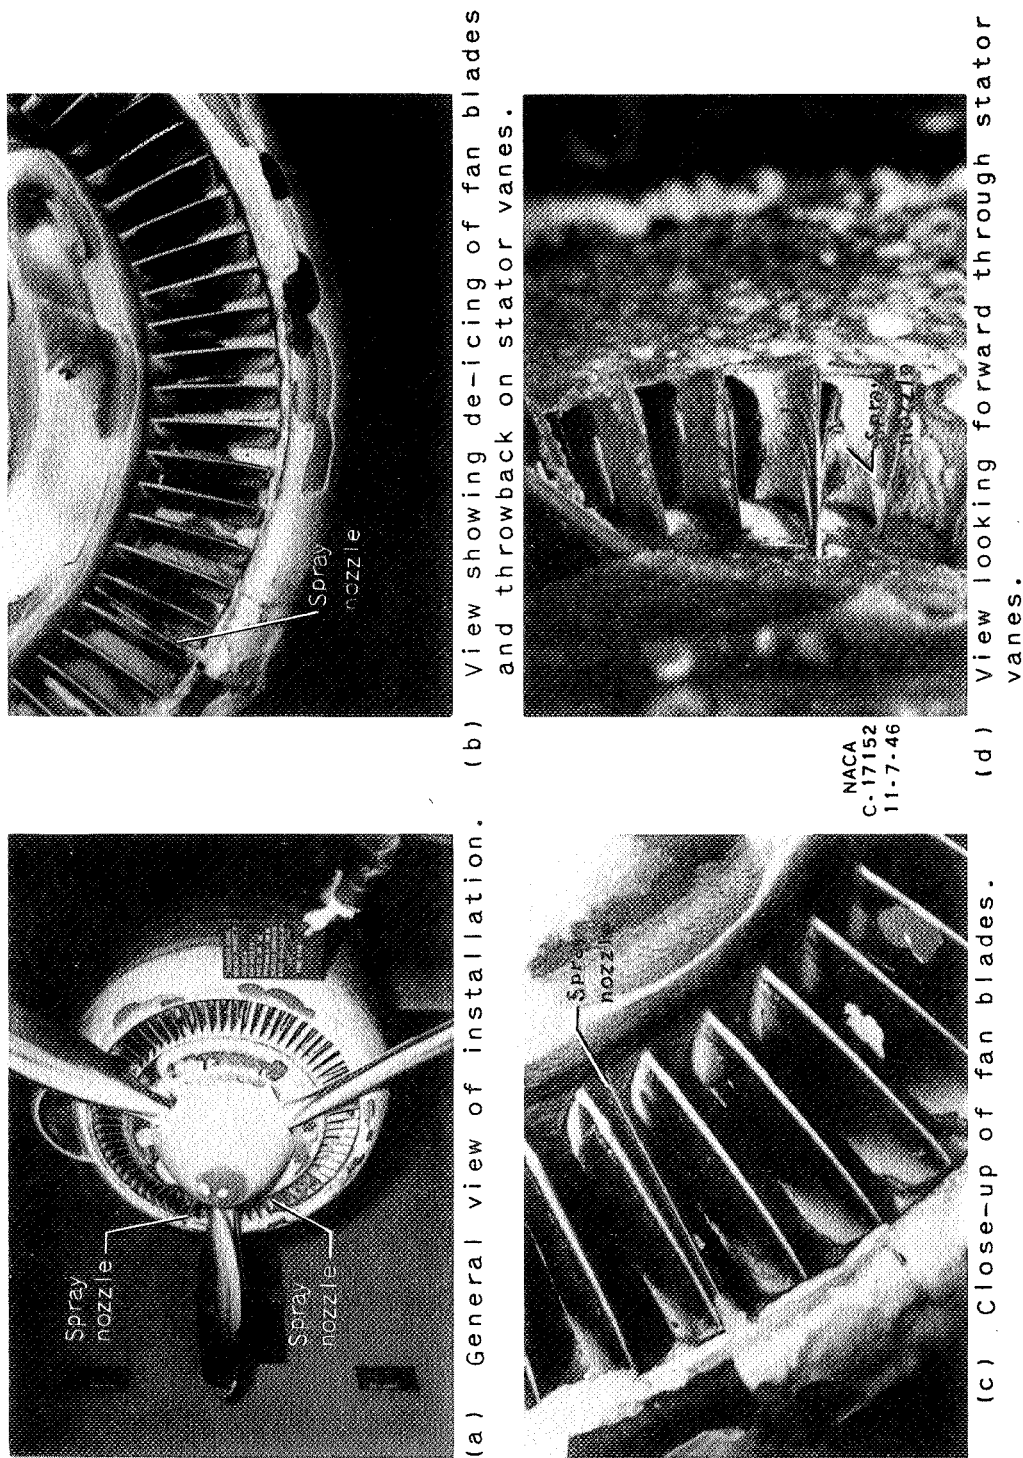
Figure 20. - Views showing effect of alcohol de-icing of cooling-fan installation at air temperature of 13° F, liquid-water content of 0.5 gram per cubic meter, fan speed of 950 rpm, and alcohol flow of 2.3 pounds per minute.

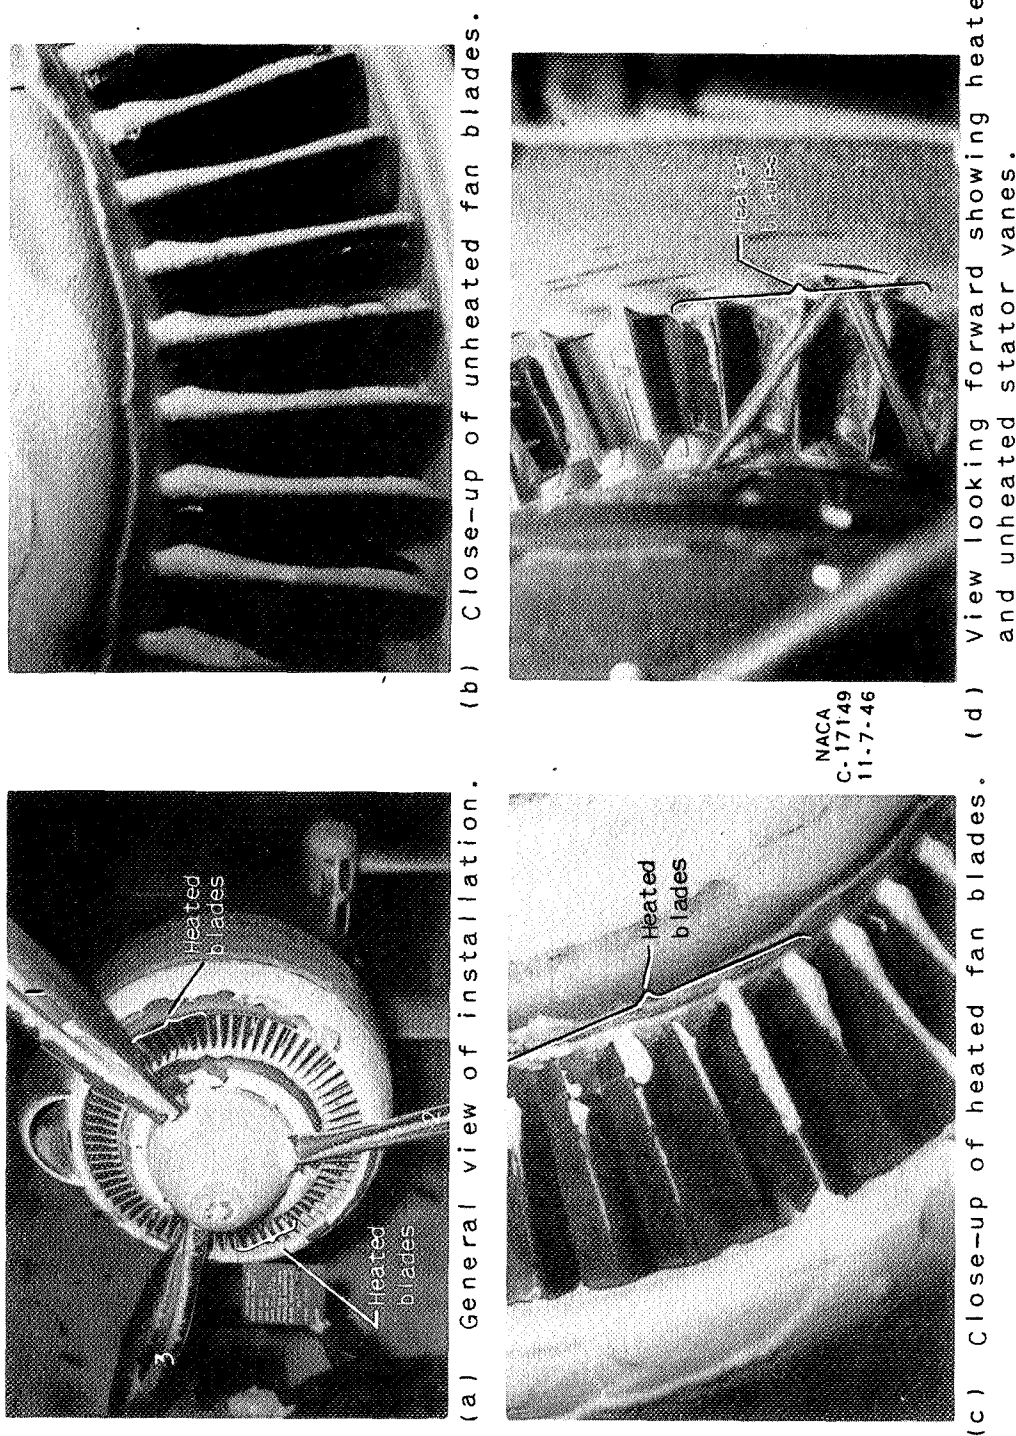
Figure 21. - Views showing de-icing of cooling-fan installation by electric blade heaters after 5-minute run at air temperature of 150° F, liquid-water content of 0.5 gram per cubic meter, fan speed of 954 rpm, and power density of 5 watts per square inch.

Electrical heat de-icing. - Photographs showing the results of the use of electric blade heaters are presented in figures 21 to 25. As only a few of the fan blades and stator vanes were heated, no fan-performance data were obtained. With an air temperature of 15°F , liquid-water content of 0.5 gram per cubic meter, fan speed of 954 rpm, and a power density of 5 watts per square inch, fairly complete de-icing of the heated fan blades resulted. (See fig. 21.) The small amount of ice at the root of the leading edge was caused by ice bridging over from an unheated part of the blade. It should be noted that the group of heated fan blades behind propeller blade 1 were partly shielded from icing by the blade shank. The de-icing of the stator vanes was only marginal with rough ice building up near the trailing edge. When the power density was increased to 6 watts per square inch (fig. 22), some improvement in the de-icing of the stator vanes resulted but rough ice still collected at the trailing edge. At a higher temperature and liquid-water content (fig. 23), complete de-icing of the heated fan blades was obtained after 5 minutes of icing. The de-icing of the stator vanes was again marginal. The effects of electrical heating at two icing conditions, each of 10-minute duration, are shown in figures 24 and 25. Both

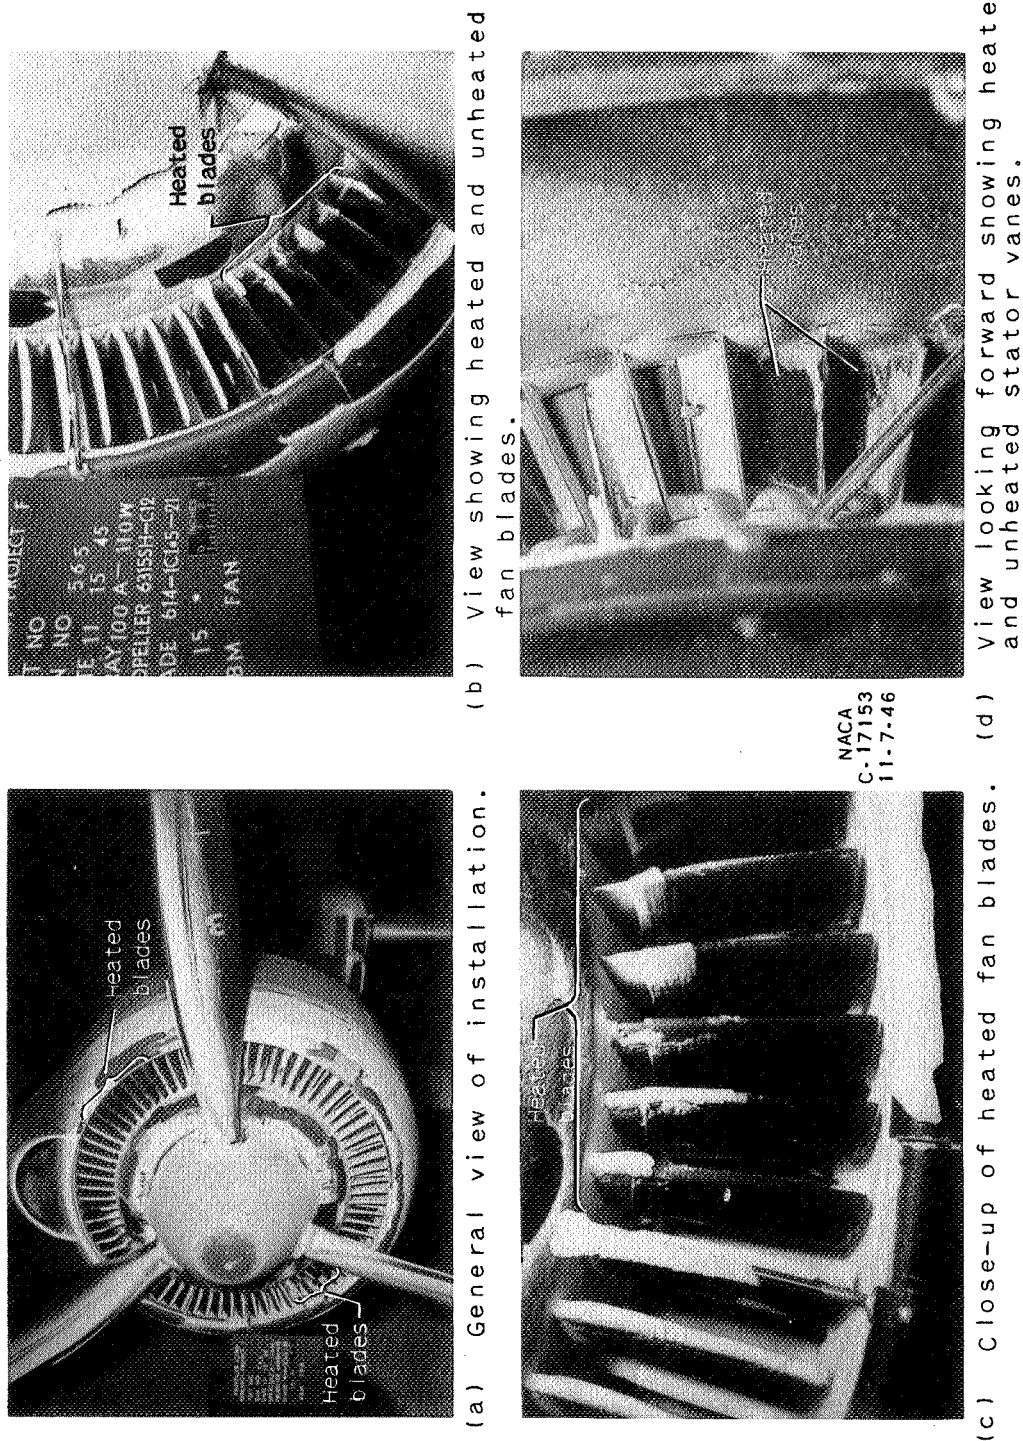
Figure 22. - Views showing de-icing of cooling-fan installation by electric blade heaters after 5-minute run at air temperature of 15°F , liquid-water content of 0.6 gram per cubic meter, fan speed of 950 rpm, and power density of 6 watts per square inch

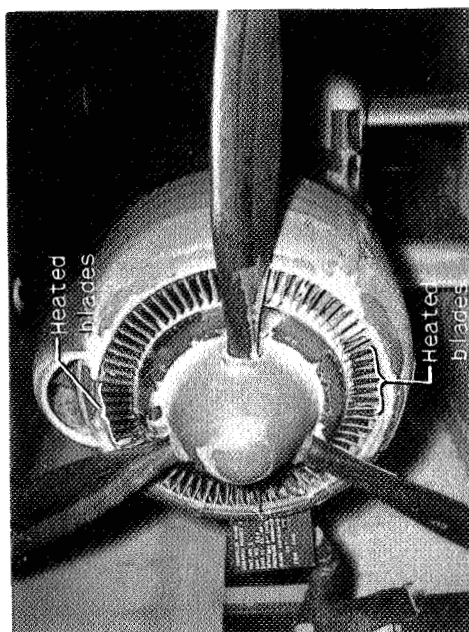
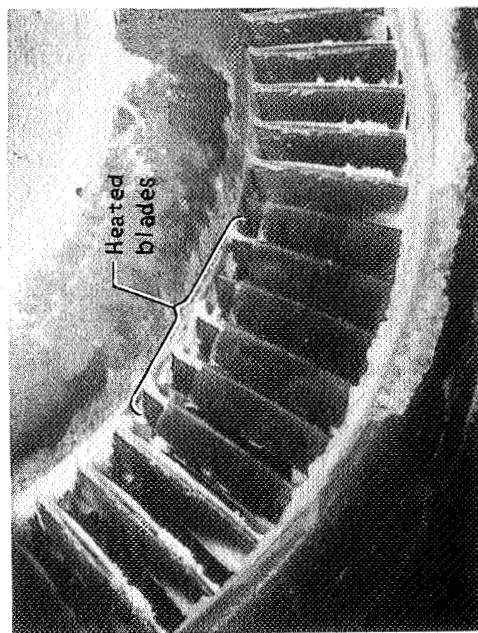
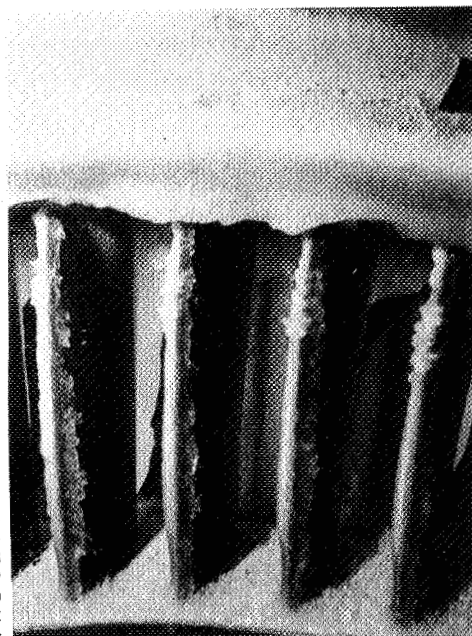
(a) General view of installation.

(b) Close-up of heated fan blades.

(c) Close-up of unheated fan blades.

Figure 23. - Views showing deicing of cooling-fan installation by electric blade heaters after 5-minute run at air temperature of 28° F, liquid-water content of 1.2 grams per cubic meter, fan speed of 950 rpm, and power density of 6 watts per square inch.

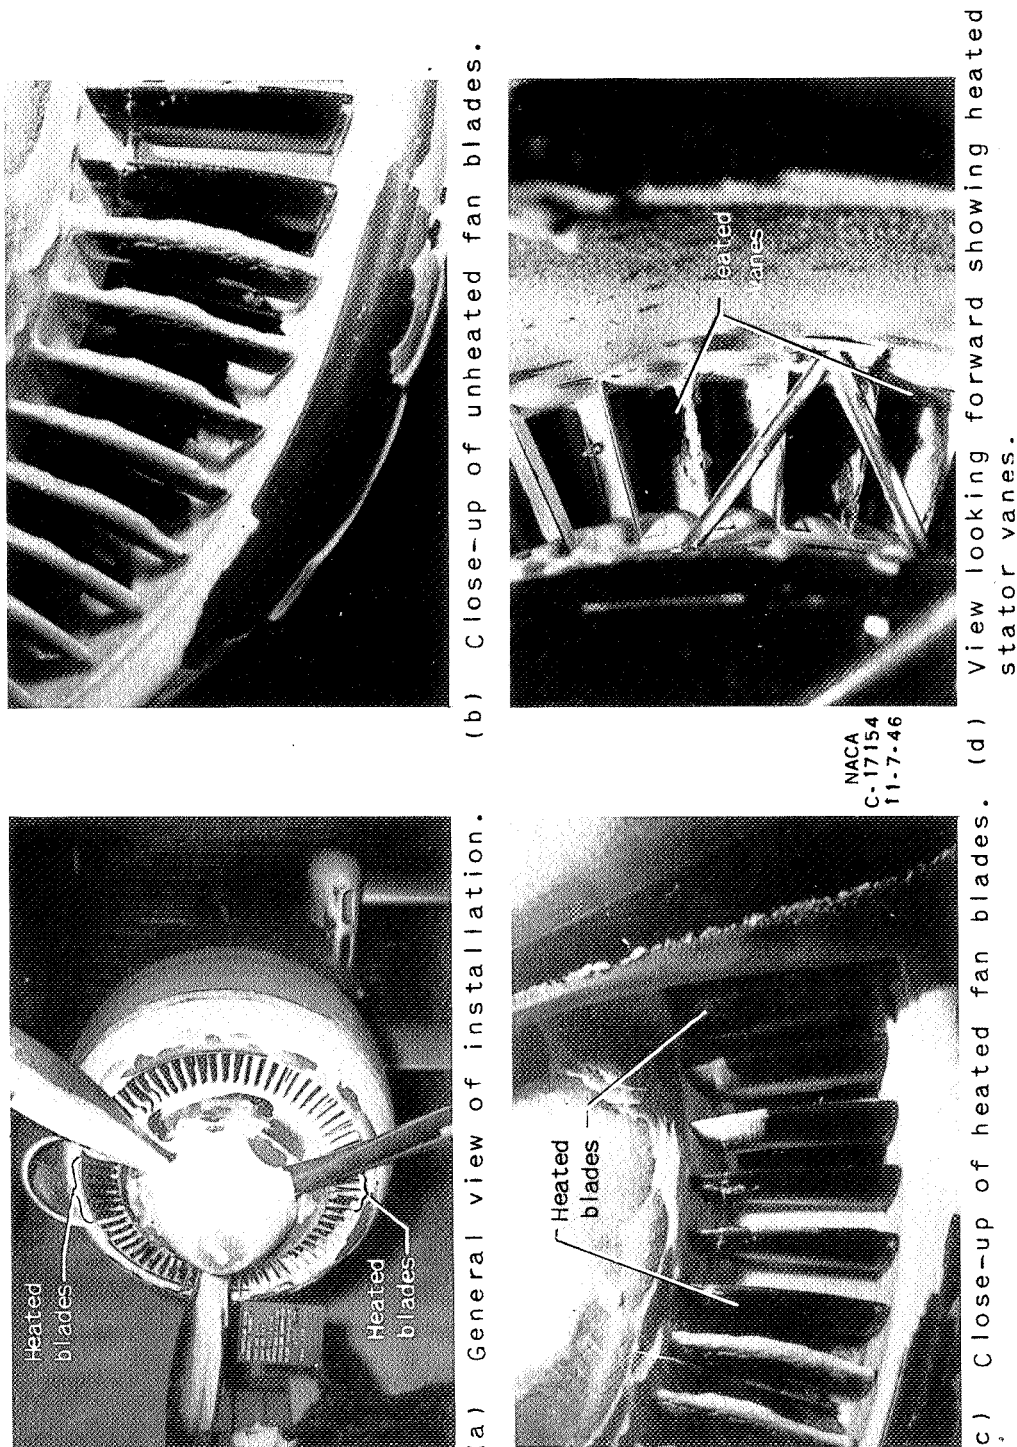
Figure 24. - Views showing de-icing of cooling-fan installation by electric blade heaters after 10-minute run at air temperature of 14°F , liquid-water content of 0.5 gram per cubic meter, fan speed of 950 rpm, and power density of 6 watts per square inch.

experiments were made at power densities of 6 watts per square inch with the fan blades almost completely de-iced. At the lower temperature, the de-icing of the stator vanes was marginal and at the higher temperature and liquid-water content, the de-icing of the stator vanes was completely ineffective.

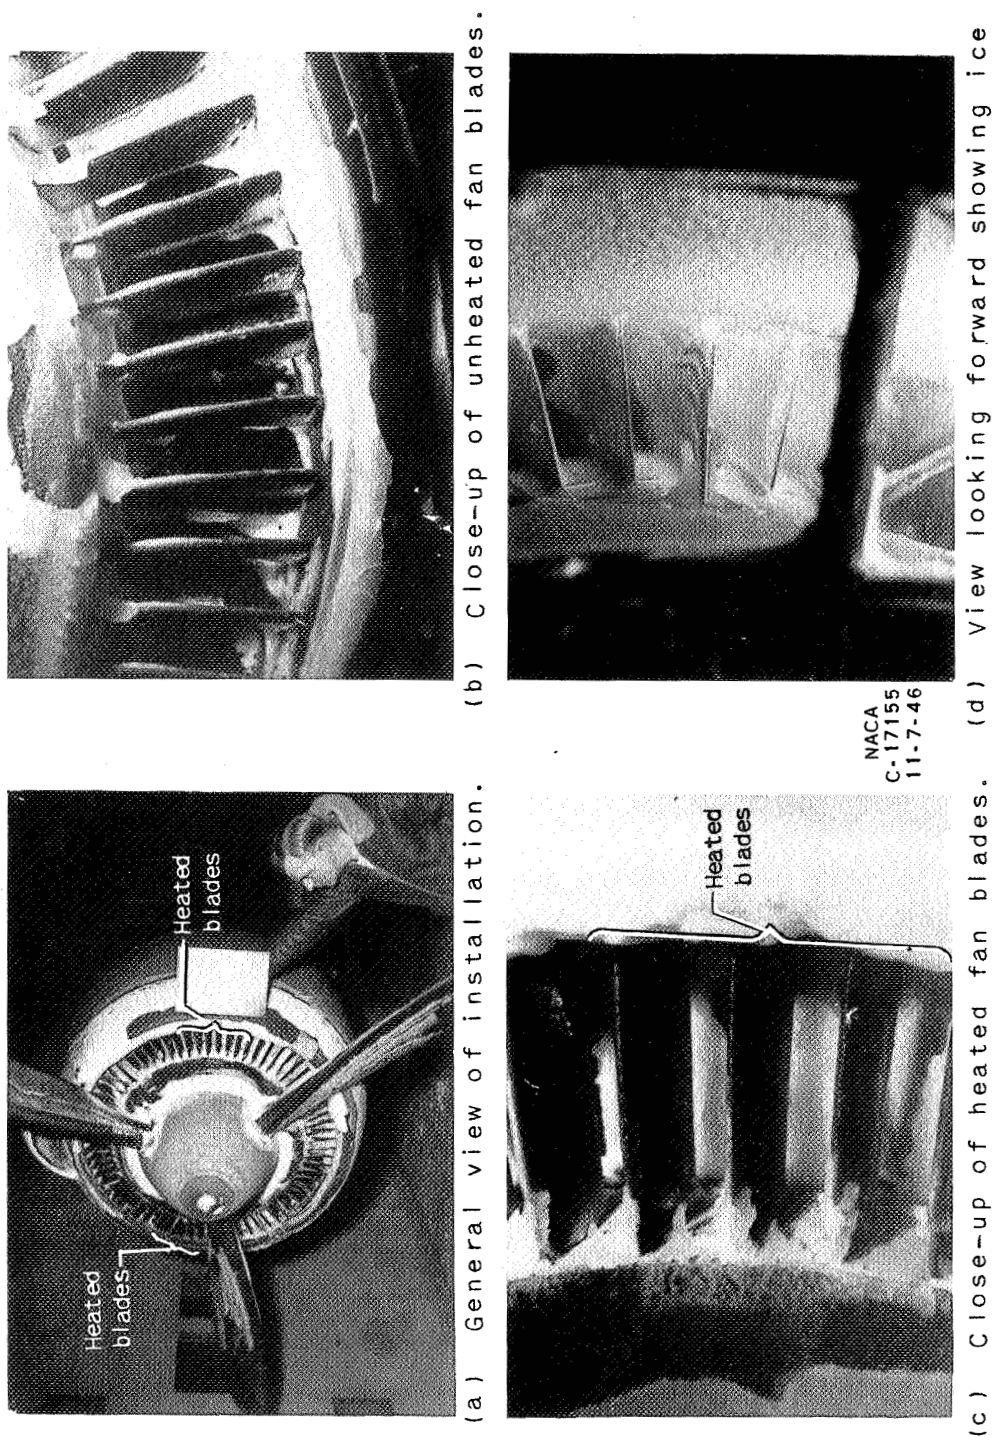
Figure 25. - Views showing de-icing of cooling-fan installation by electric blade heaters after 10-minute run at air temperature of 22° F, liquid-water content of 1.0 gram per cubic meter, fan speed of 952 rpm, and power density of 6 watts per square inch.
